Location of damp issues

Internal symptoms of the damp on the wall facing the side return passage

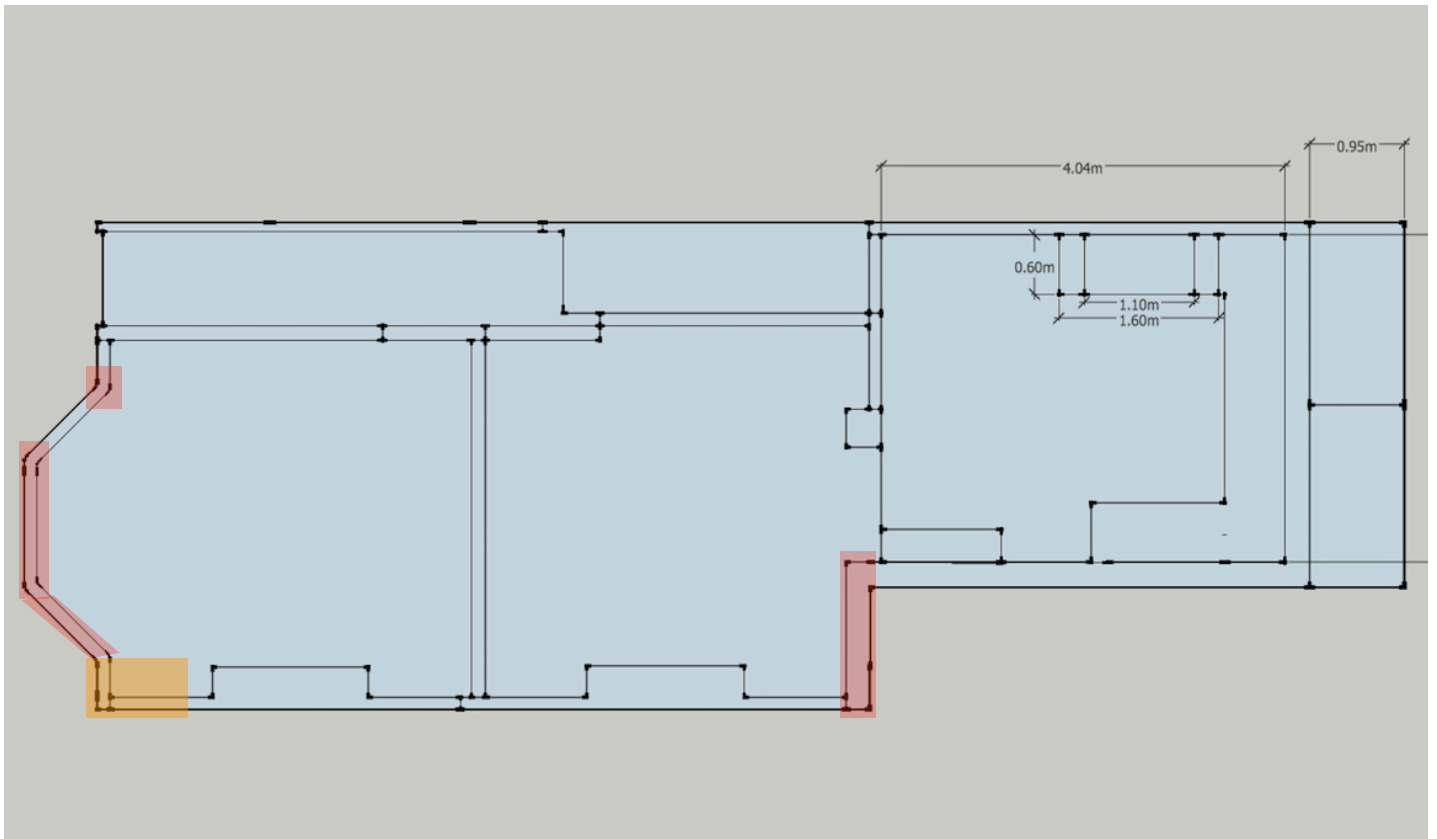
- Red: Areas with bubbling paint etc showing
- Yellow: Areas with bubbling paint and rotten floor joist

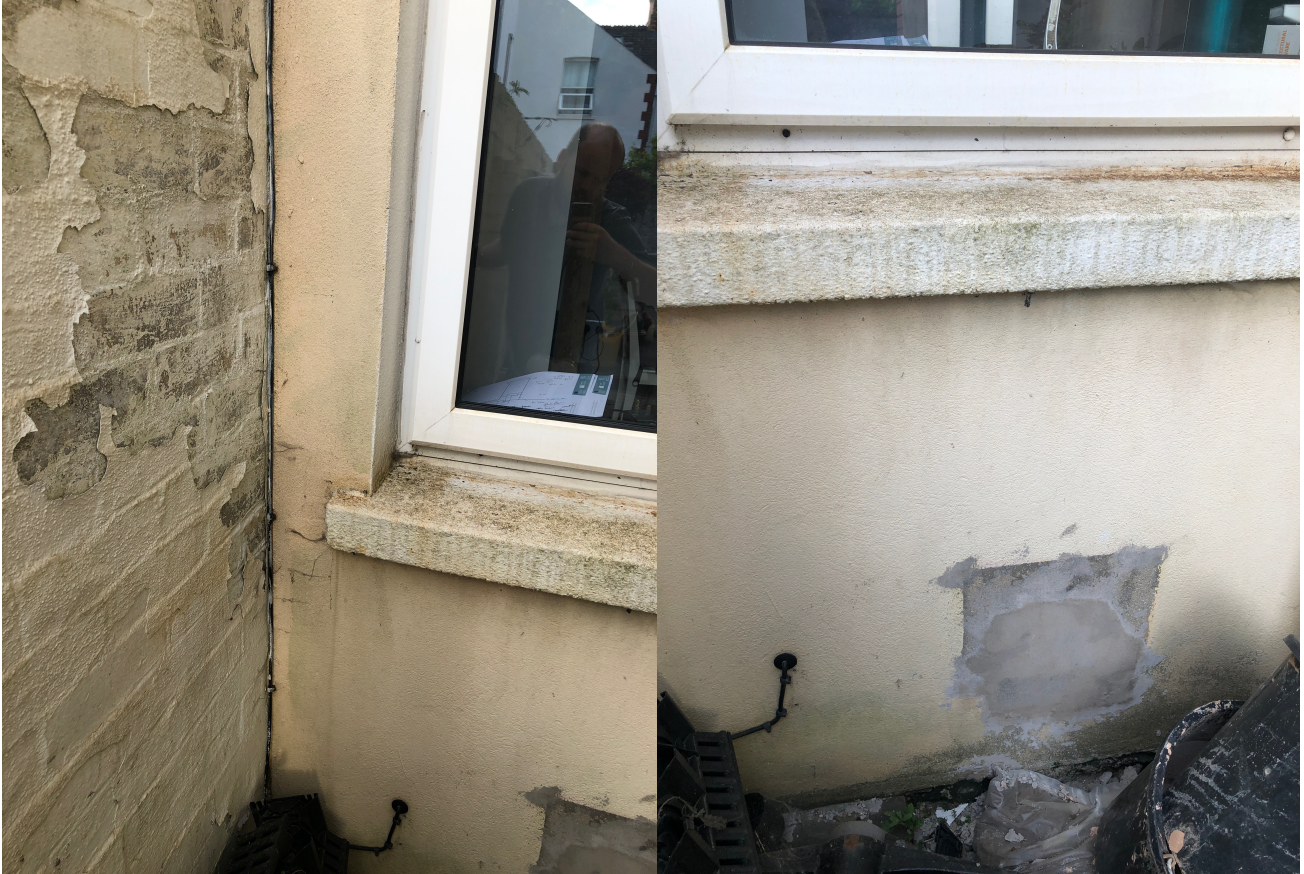
External wall next to side passage

On the small external wall next to side passage, there is what I presume to be an original air vent that has been removed/blocked up fairly recently. After investigating internally, below the floorboards there were remains of what looked like a large clay air vent that had been smashed at some point. No ventilation what-so-ever on this side which is obviously a concern given the timber suspended floor.

- There is green discolouring on the wall roughly corresponding to the bubbled paint internally.
- The external render goes all the way to the floor all around the back of the property (yet notably only appears to be an issue on this part of the property. Worth noting that all other areas would hit a solid floor rather than the suspended timber floor located here.
- There is single brick wall separating us from the neighbours which I believe originates from the construction of the property. As this is butted up against the property, could damp be penetrating through this specifically? There is also some green discolouring on this wall on first course or two of bricks.

1. As there is already a cavity from the original vent which is centred below the window, my thoughts are to cut back some more of the bricks and reinstate some airflow using telescopic air vents.

3. As the external render is going all the way down to the ground level of the flagstones (which I believe are the originals flags), would I be correct in presuming that the render will be wicking up surface water and possibly penetrating through in this way? In which case the solution in mind is to cut back the render to a height of about 150mm, enabling the bricks to breathe.

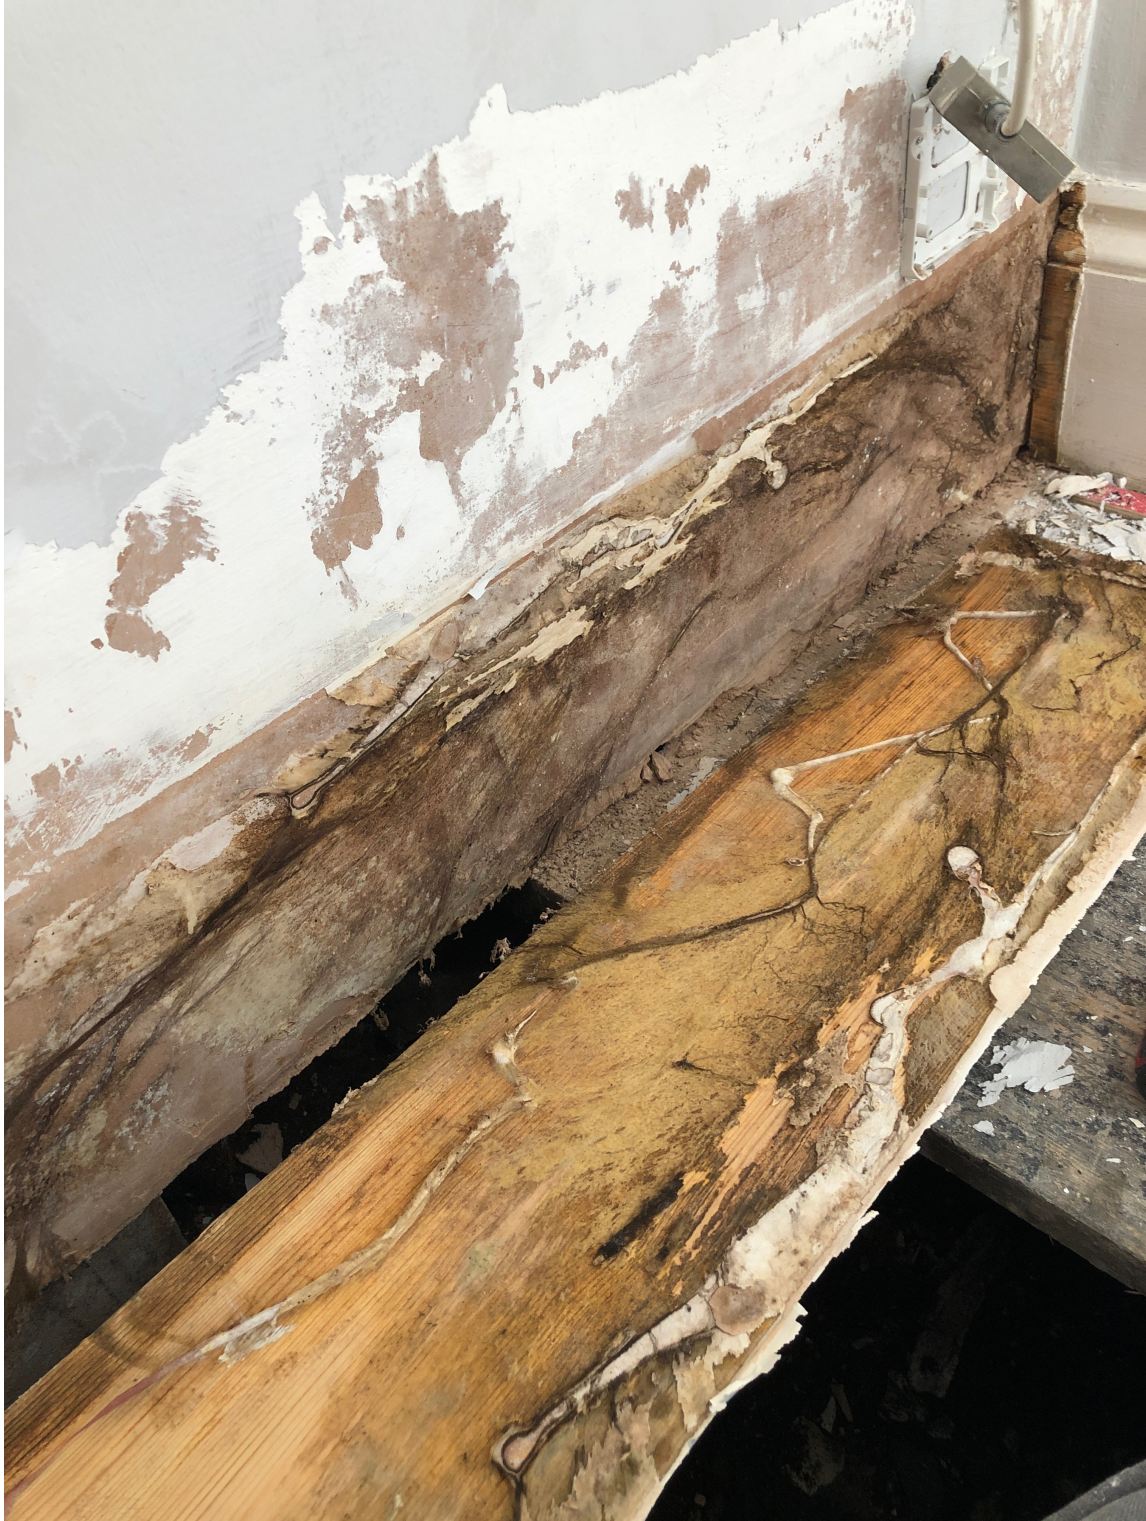
- When removing the skirting boards in this area, there is some very concerning growth:

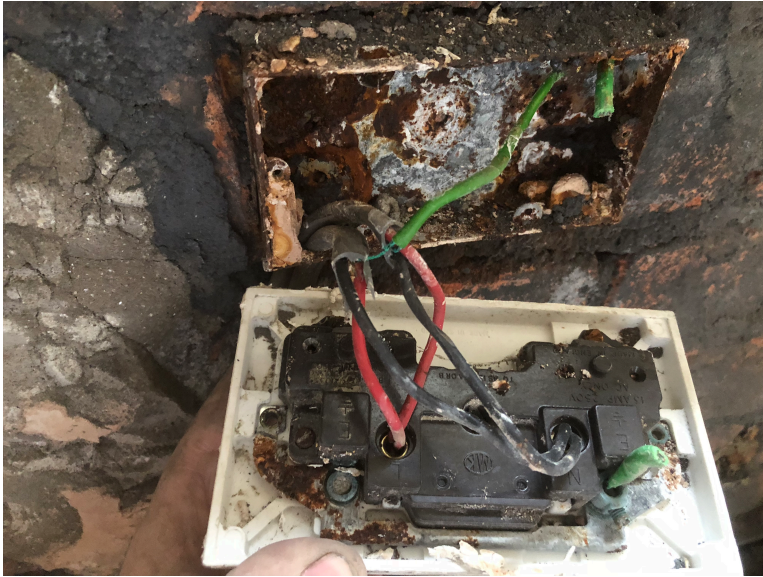
- Removing the faceplate off an electrical socket located about 45cm up, the back box is heavily corroded. The main water supply through a lead pipe used to be located nearby, but has recently been removed. I guess it is likely this could have been slowly seeping and a factor in slowly saturating the wall, but I don't know for sure.

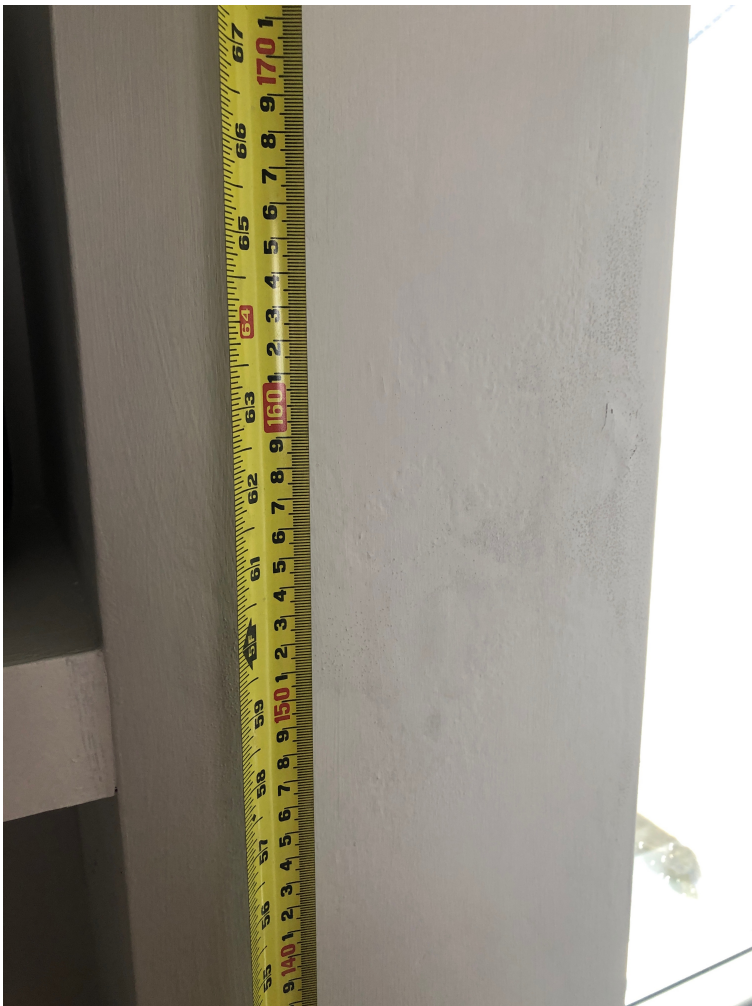
- About 160cm up, to the left of the window there are some small areas of paint bubbling, which I believe roughly corresponds to the maximum height that damp will travel up. Not sure if there is another reason for this but it seems relevant to the whole situation.

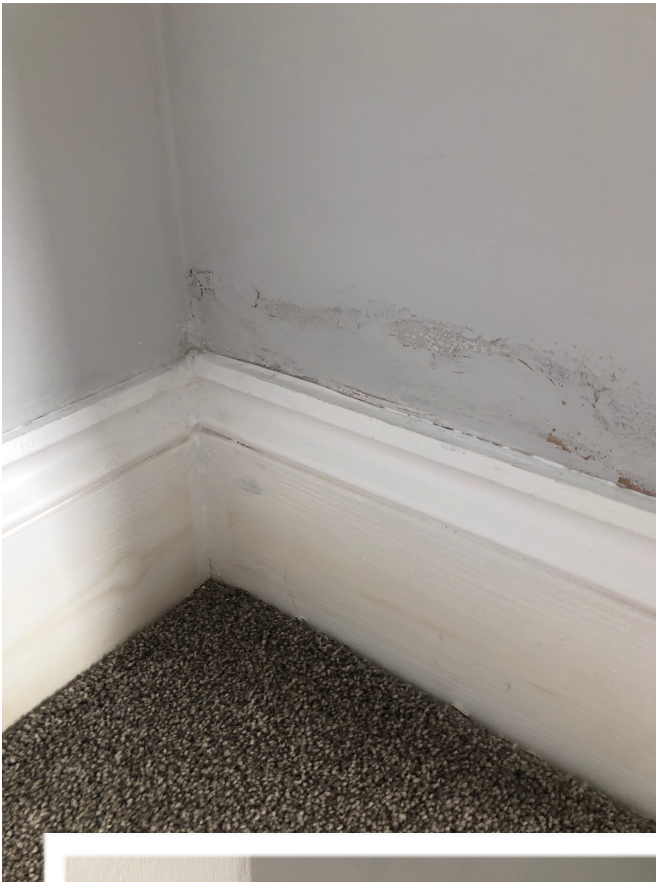
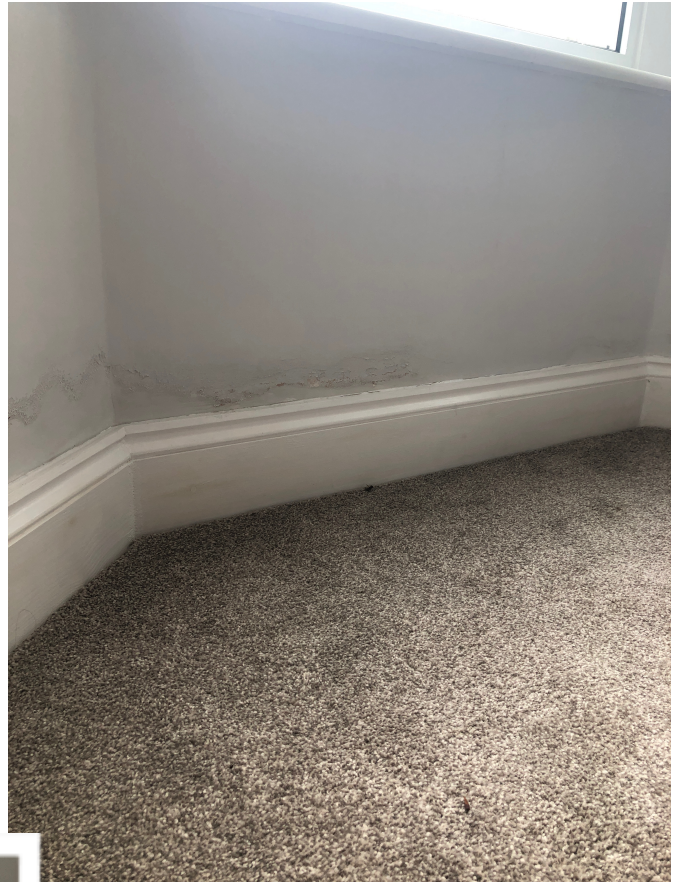
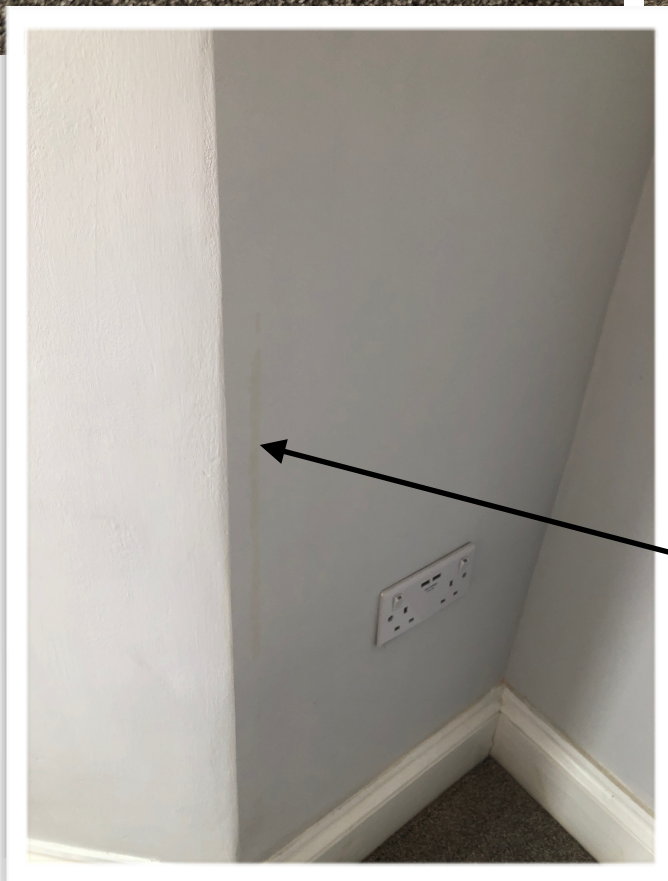
Yellow staining coming through paintwork

The paint has been bubbling up in patches, and skirtings yellowing. Scraping the paint, it appears similar to what I would expect effervescence to be. Tried cleaning off on patching the paint temporarily, but reappeared in no time.

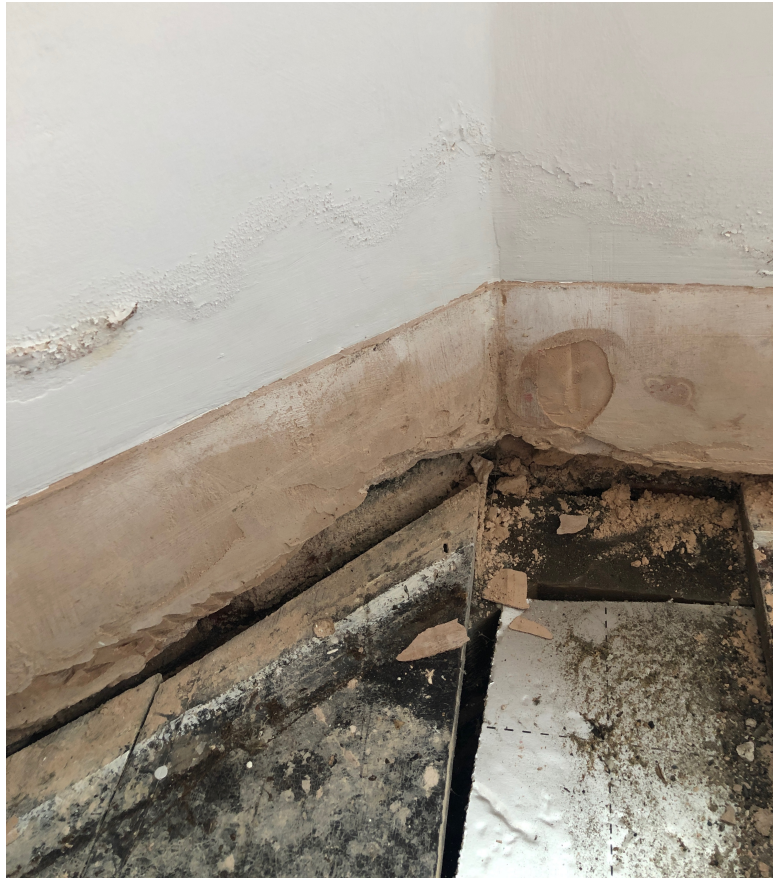
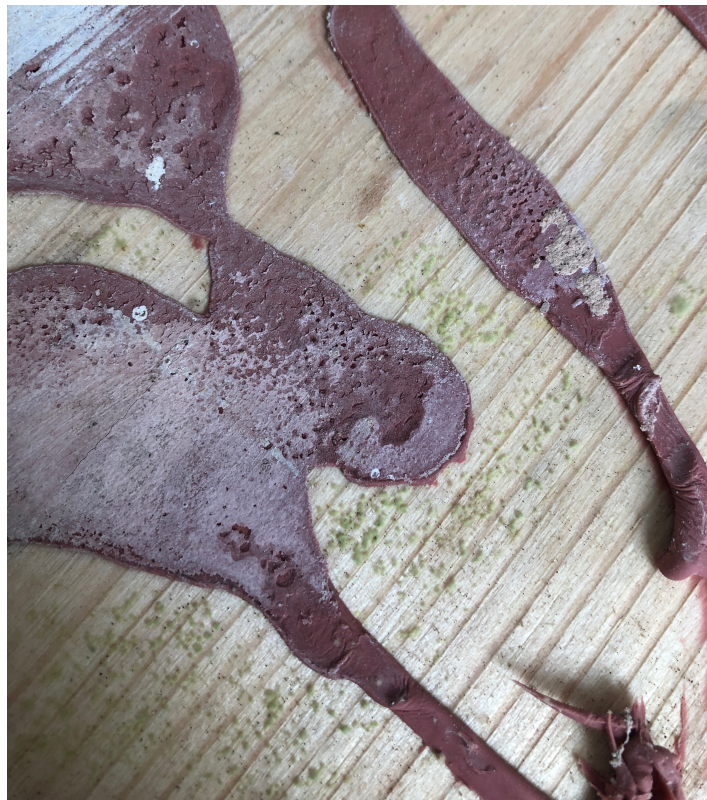
Strangely, when removing the skirtings and pulling back the carpet, not much showing on the wall to indicate any damp. On the skirting that were turning yellow, there is however some strange green growth on the back - what is it and should I be concerned?

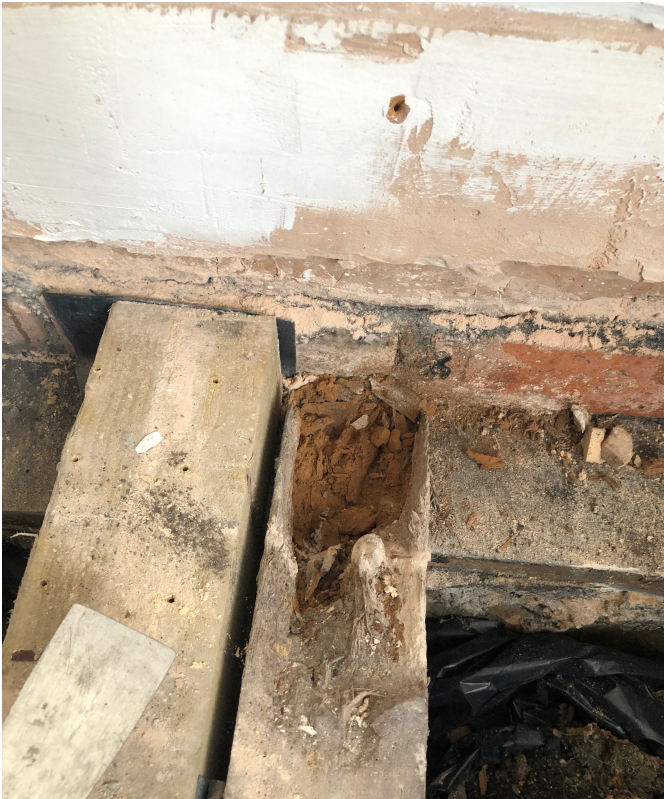
Further investigation and pulling back some of the floor revealed that one of the joists on the left hand side of the bay window has rotted, and has been braced with by another length of tanalised timber. Looking further under the floor, the strip of timber on the stone supports of the floor has this growth on it - any ideas?

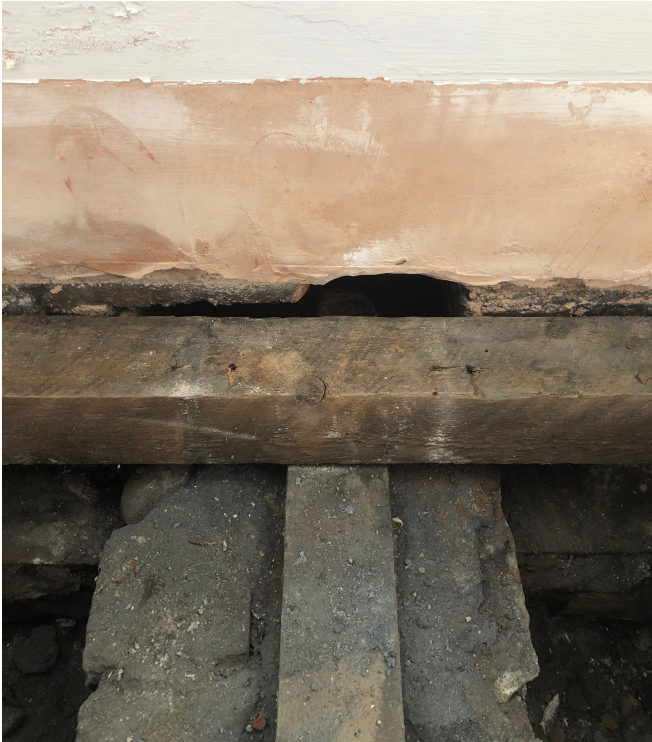
There is a vent just below the floorboards and centre to bay window. Whilst still circulating air, it was about 3/4 filled with soil and debris. This has now been cleaned out. Internally there is a beam directly in front of it as shown in the picture, but there is about an inch of a gap below for air to now freely circulate.

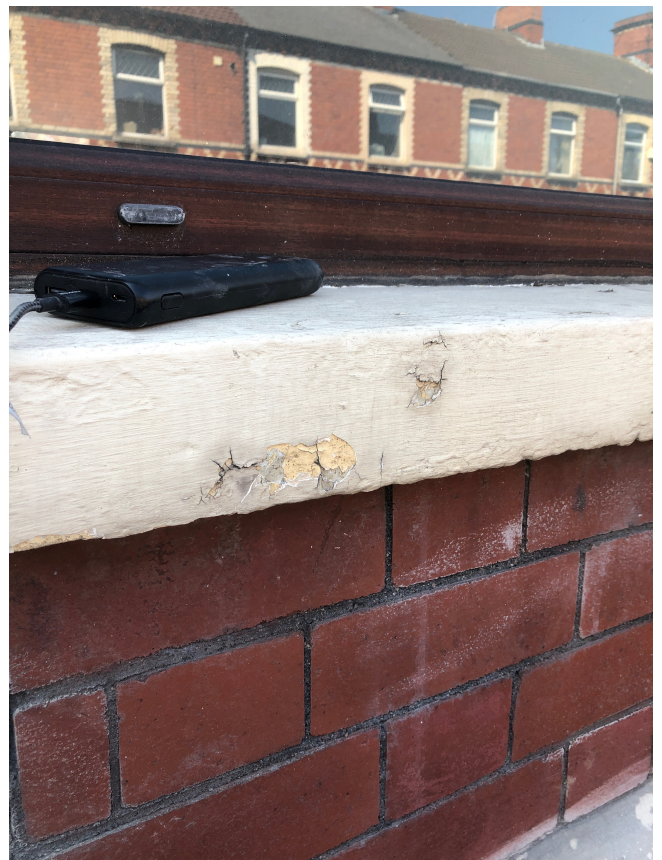
The exterior of the bay window is in need of some TLC but there are no obvious failings. The pointing is mostly in good shape and I couldn't see anything that suggested being the source of any of the damp issues penetrating through. I did spot some areas where the pointing had deteriorated, which have now been re-pointed.
